Assessing Hurricane Katrina Vegetation Damage at Stennis Space Center using IKONOS Image Classification Techniques

Joseph P. Spruce and Kenton W. Ross
Science Systems and Applications, Inc.
John C. Stennis Space Center, MS 39529

ASPRS 2007 National Convention
Tampa, Florida, USA
May 6-11, 2007

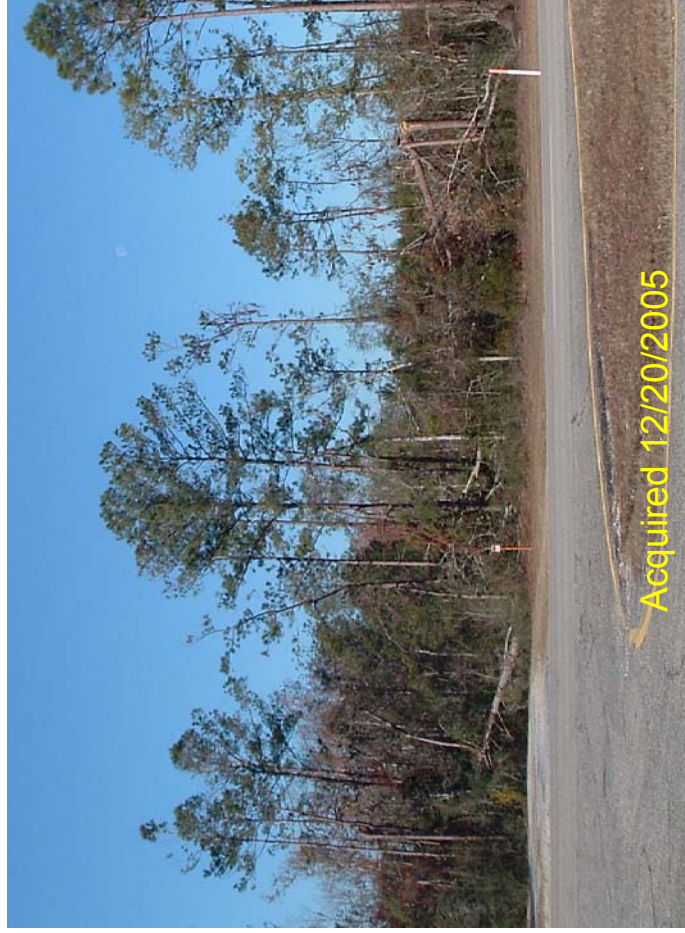
Semi-Open Pole-Sized Pine Overstory
Wind-Snapped and Wind-Thrown Trees
Sparsely Foliated Residual Crowns
Thick Ground Cover

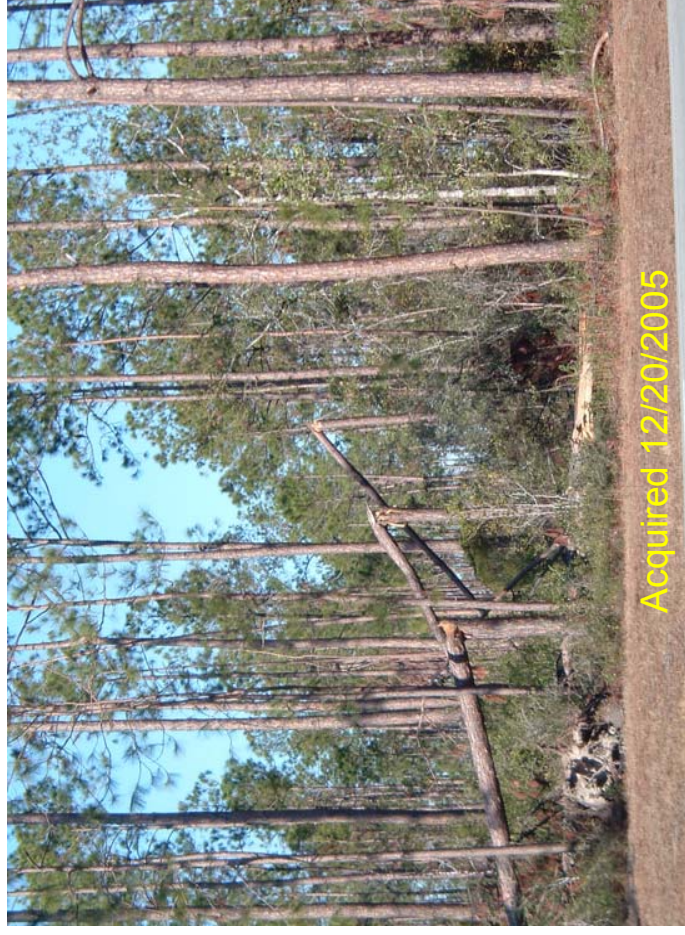
Mature Dense Pine Overstory
Wind-Snapped and Wind-Thrown Trees
Reduced Crown Foliage
Moderately Thick Ground Cover

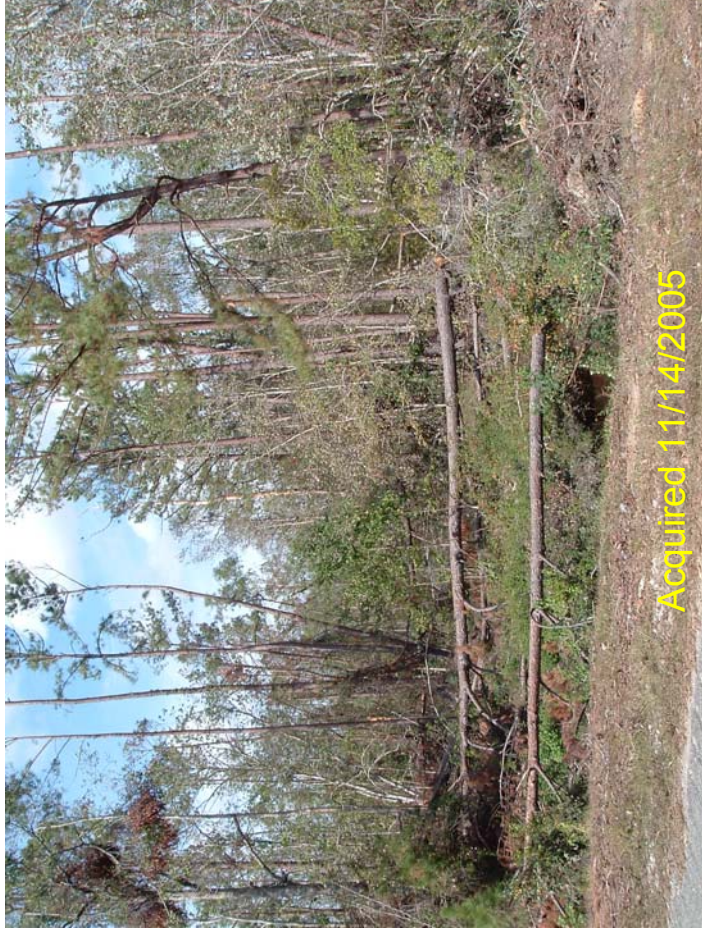
Mixed Wood Riparian Forest
Wind-Thrown Trees Overlain on Creek
Thick Ground Cover

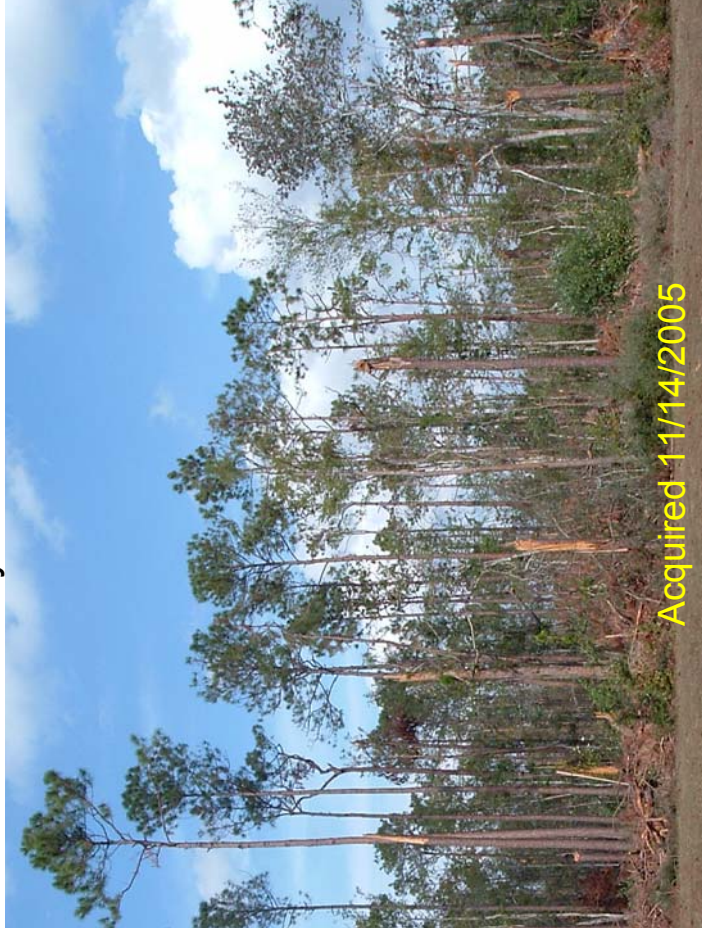
Pole-Sized Pine
High-Density Wind-Snapped Trees
Moderately Thick Ground Cover
